MALMESBURY MARKET CROSS

2023 Condition Survey

dittrich**hudson**vasettiarchitects

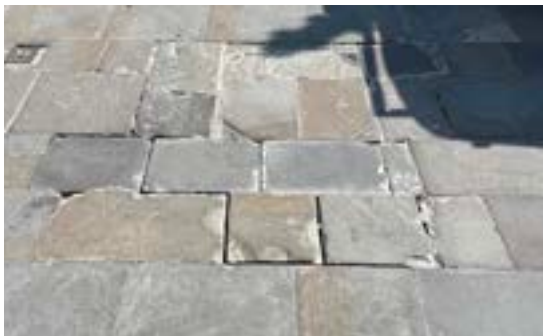
Photo 1.4.5c: Damaged paving from vehicles

- 1.4.4 The loft hatch is rotten and needs to be replaced with a new lead cover.
- 1.4.5 The landscaping around the monument needs improvement. Drains are blocked and the southern paved area does not drain well. The north of the Market Cross is very vulnerable to vehicle strikes and has no protection from the constant stream of vehicles that park and turn in close proximity to the stonework. Parking against the monument significantly mars the setting and safety of users. The stone paving in the square is deteriorating due to heavy vehicle movements.

1.4.6 The monument needs protection with wider pavements; a high kerb; bollards; traffic control. This would require a landscape project that will have to extend into the square. This is probably the most important recommendation of the condition survey.

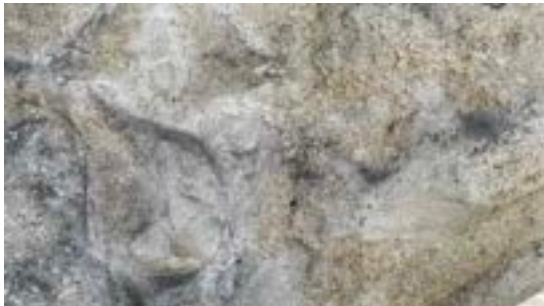
Photo 1.2a

1.2 Bay 1 (N) has a very weathered spandrel to the east (photos 1.2a and 1.2b), and a crisper, leaf-carved spandrel to the west. There is some scaling to the east spandrel and arch stone. The low-level ashlar is very worn and joints are washed out and would benefit from pointing (2). The buttress crocket finials are intact (they are 'engaged' stone so will be secure) – see photo 1.2c. There is some weathering of stone below the parapet, and to the base stone (photo 1.2d), but this doesn't warrant conservation work for now. Moss should be removed from the string course (1). The buttress finial to the south is secure.

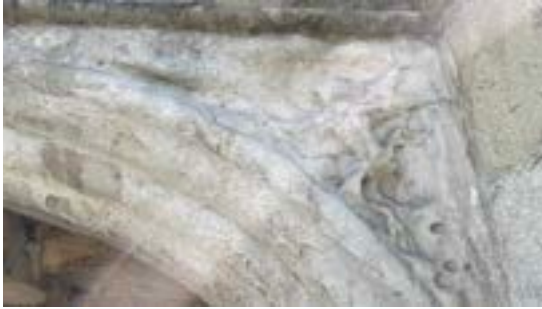
Photo 1.3a

- 1.3 Bay 2 (NE) has quite weathered spandrels (photo 1.3a) and the arch stonework is quite scaled (photo 1.3b). There is a small area of mechanical damage to the south and some blistering to the north (photos 1.3c and 1.3d), however, no conservation work is warranted for now. A finial crocket head to the south is loose. It is secured by a rod but needs to be re-pinned and pointed (1) – see photo 1.3e. The parapet stonework is weathered, but apart from moss removal (1), no conservation work is warranted.

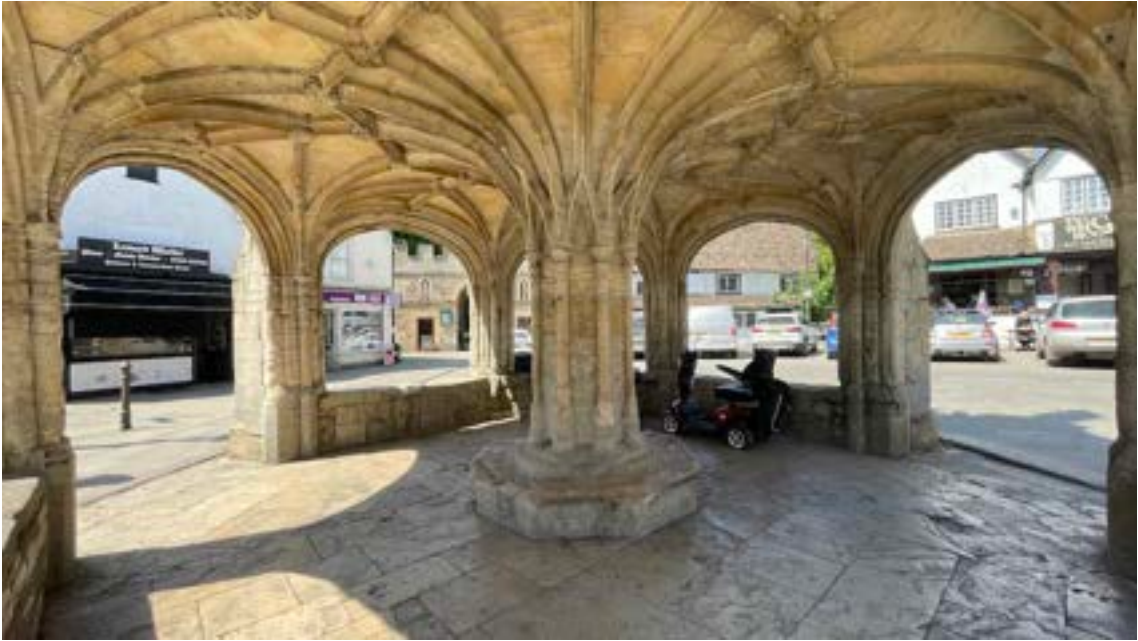
Photo 2.1

- 2.1 The interior is formed from a central, octagonal shaft and eight four-centred perimeter arches. Ribbed tierceron vaulting springs from the shaft and arch piers. Floor paving is limestone, almost certainly replaced in the twentieth century. The arch openings are infilled on six sides with low-level mixed coursed stone – some in regular courses and some in ashlar, of a variety of limestones and sandstones. The infill walling has been in place since at least 1683 (it is shown on the engraving of this date). The northeast (Bay 2) and southwest (Bay 6) arches are open for access.

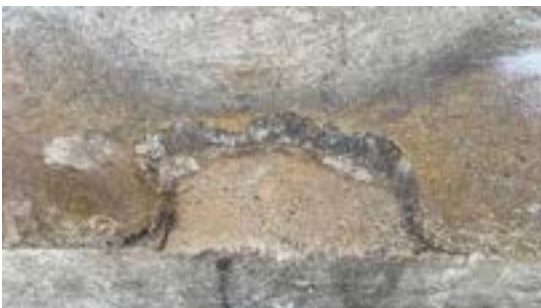
Photo 2.2a

- 2.2 The central shaft has a very worn bench seat. The shaft base above is very scaled with spalling stone. All carving detail has gone. Some conservation work would be ideal, but it might be vulnerable to damage at sitting level.

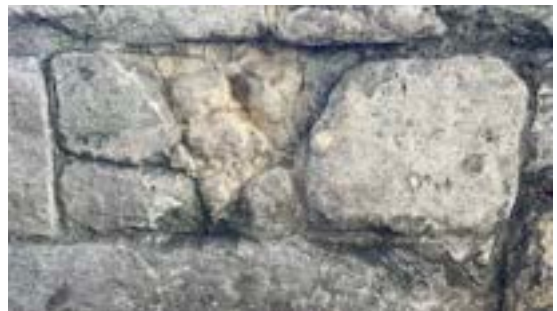
Photo 2.6b

2.6 The outer shaft stonework to Bay 1 (N) is scaled in places. There are mortar repairs to the west jamb. All is fine for now. The low wall is of weathered coursed ashlar with infill stones to the west. Some are fractured and would benefit from mortar repairs (2) – see photo 2.6b.

2.00	<u>Work which should be undertaken within the next 4-5 years</u>	Under-taken by TC	Text Reference	Approx Cost (£)
2.01	Commission a small programme of stone repairs – Mortar repair or fit stone replacements to the friable stone beneath the gutter spout to Bay 3 (E); repair the small crack to the Bay 3 north buttress arris; repair the small crack to the Bay 5 (S) buttress arris; rake-back and repoint the small crack to the Bay 7 (W) jamb stone; mortar repair fractured external plinth stonework on Bay 1 (N); mortar repair the spalling external plinth stone to Bay 2 (NE); de-frass and shelter coat the very eroded stone to the east outer jamb of Bay 5 (S); and the south jamb of Bay 6 (SW).	N	1.3; 1.6; 1.8; 2.6; 2.7; 2.10; 2.11	2,500

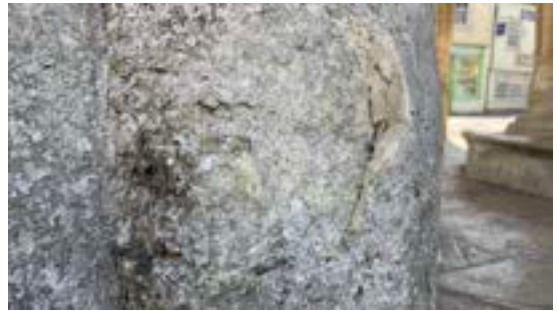
Photo 2.7b

2.7 The open Bay 2 (NE) stone surrounds are weathered to the north. There is a fractured stone to the south at low level which needs a mortar repair to protect it from being knocked off and losing the face (2) – see photo 2.7b.

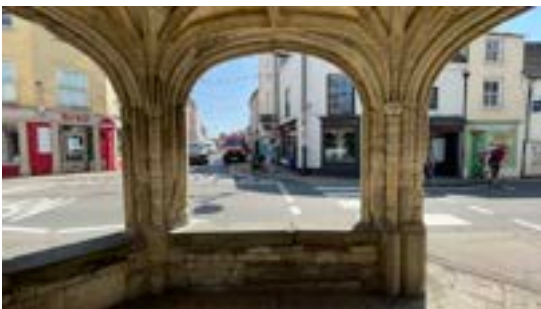
Photo 2.10a

2.10 The east jamb of Bay 5 (S) is very eroded at the base. Stone replacement will be needed in time (3) for now de-frassing and shelter coating may prolong the life of the stone (2). The wall is of squat, coursed squared-rubble with sandstone copings and is markedly different from the outer low wall stonework. Joints are open but the rounded rubblestones won't take re-pointing well.

3.02	Replace the very eroded stone to the east outer jamb of Bay 5 (S).	N	2.10	750
3.03	Replace the lead patches to the gutter flashings, or renew the flashings in shorter lengths.	N	3.5	2,500
Total of all long-term works excluding VAT, fees, contingency and inflation (£)				5,250

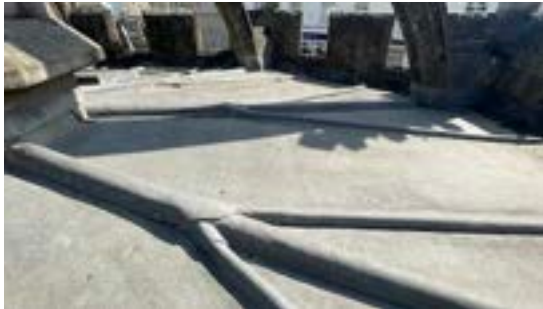
Photo 3.2a

3.2 Lead bays are a maximum of 2.5m long by 0.8m girth, which is adequate for code 7 lead or thicker. Boards are showing through in places, and there are four lead patches. The lead welds to three of these have hairline cracks and should be replaced with larger patches (1) – see photo 3.2b. The upper gutter bays (ie. bays without catch pits) are formed from single pieces of lead welded to a small apron at the catch pit. They are therefore restrained at the point the lead passes through the buttresses. This lead weld will be prone to splitting (a tiny split is forming to Bay 1 (N) – see photo 3.2d). These points should regularly be inspected and lead patch repaired when required (1).

1.03	Regularly inspect the vent meshes to ensure pigeons don't access the roofspace.	Y	1.9	-
1.04	Commission a programme of minor lead repairs – replace lead patches to three lead patches on the roof. Regularly inspect the restrained upper lead gutter bays and patch weld any forming cracks. Replace the gutter upstand lead patch to Bay 7 (W). Repair the crumpled end to the drainage chute to Bay 5 (S), including access.	N	3.2; 3.5; 3.6	1,500

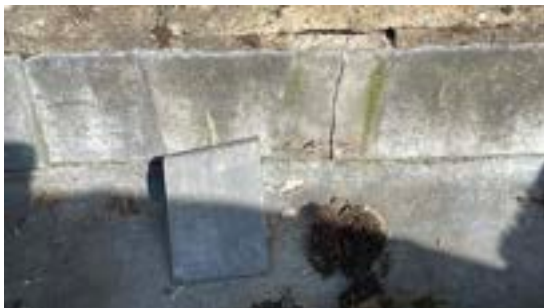
Photo 3.5a

3.5 Parapet flashings have small flashing patches over splits (the flashing are over-long). The Bay 7 (W) patch has come out and needs to be wedged and re-mortared (1) – see photo 3.5a. It is suspected that these patches are not wedged and all may need attention in forthcoming years as thermal movement loosens them (3). The flashing to Bay 6 (SW) has a crack which needs a patch in the longer term (3) – see photo 3.5c.

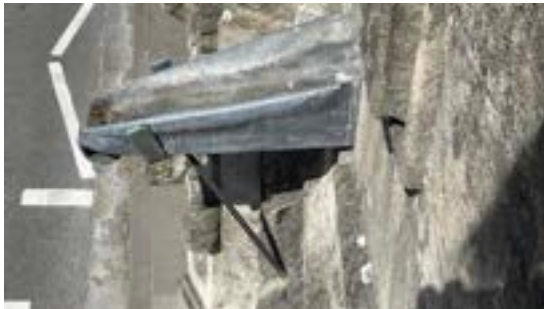
Photo 3.6a

- 3.6 The four drainage chutes are held on bronze Y-brackets. The end of chute to Bay 5 (S) is crumpled due to damage and needs to be repaired (1) – see photo 3.6a.

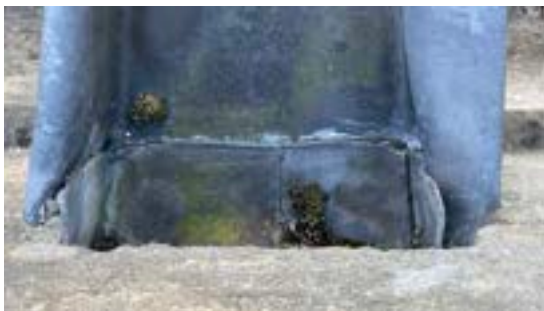
Photo 3.7

- 3.7 The chute to Bay 6 (E) has a lap joint which has a mastic bed (which has failed) – see photo 3.7. Ideally the lead chute should be a single piece, as other chutes, but the joint is beyond the outer stone moulding so any leaks shouldn't be too problematic as they will drain externally.

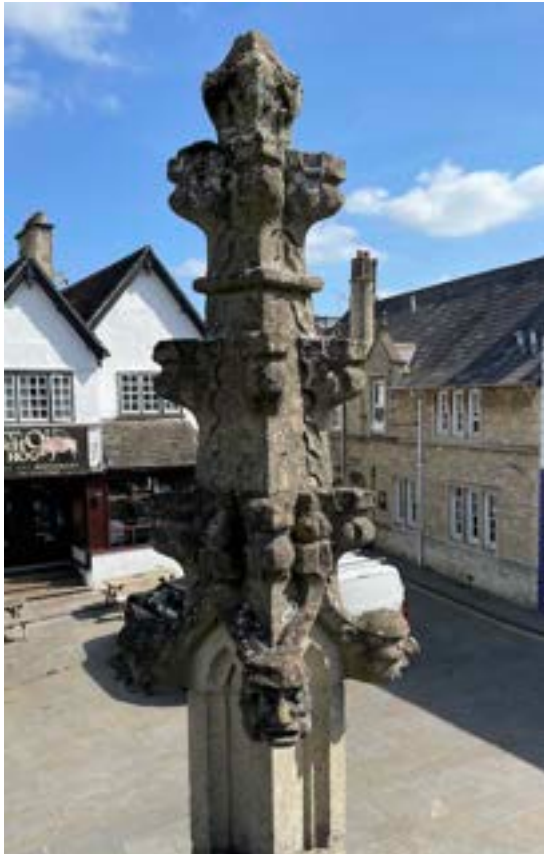
Photo 3.11a

- 3.11 The crocketed finials all appear to be in good condition visually. The two flanking finials to Bay 1 (N) (photos 3.11a and 3.11h) both wobble about the bed joint. They will undoubtedly have metal internal rods, so should be secure, but they do need re-setting and additional bed joint dowels to strengthen them (1).

1.01	Remove moss from string courses (including access) and the leadwork	N	1.1; 1.2; 1.3; 1.4; 3.4; 3.8	600
1.02	Re-pin and repoint the loose finial projecting small crocket figurative heads to Bay 2 (NE); Bay 5 (S); and Bay 7 (W); and re-secure the entire length of the two flanking finials to Bay 1 (N).	N	1.3; 1.6; 1.8; 3.11	1,800

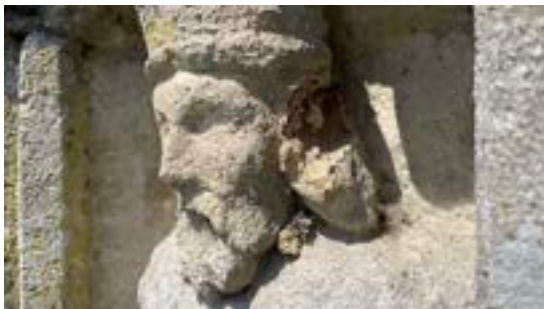
Photo 3.15a

- 3.15 The fine carving is vulnerable to weathering. There are a lot of previous mortar repairs, some of high quality, and some are now detaching. There is blistering to the left ear of King Athelstan , and to the cusped mould over Bay 5 (S). Protective lead weather hoods may arrest deterioration, and some conservation treatment would be ideal to prolong the life of the statuary (2) – this may be more cost-effective by rope access.

2.02	Replace the adjacent rusting litter bin to the north.	Y	1.9	500
2.03	Replace the rotten roof hatch.	N	3.9	1,250
2.04	Commission a programme of rope access conservation repairs to the vulnerable lantern statuary.	N	3.15	5,000
Total of all work which should be undertaken within the next 4-5 years excluding VAT, fees, contingency and inflation (£)				9,250

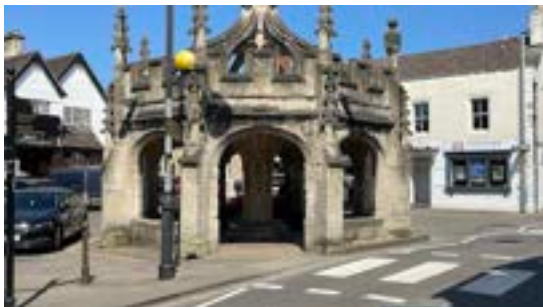
Photo 4.3a

- 4.2 Re-paving the margin stonework with dished channels and better falls from the south in particular would be desirable (**4**).
- 4.3 A high sandstone kerb to the south road provides limited protection from vehicles. Lorries in particular struggle to make the turn from High Street to Gloucester Street and there is a high risk of vehicle strike here, but there might not be much scope for improvement to the junction. CCTV coverage would be very useful to cover this junction so that vehicle strike damage can be pursued via vehicle insurance – HGVs are frequently routed through the town when drivers use inappropriate sat navs (**4**).

4.02	Install CCTV cameras and enforce traffic restrictions at the junction between the High Street and Gloucester Street to reduce the risk of vehicle strikes against the monument at this vulnerable point; and to discourage unauthorised access to the roof of the Market Cross.	N	4.3; 4.6	Unknown

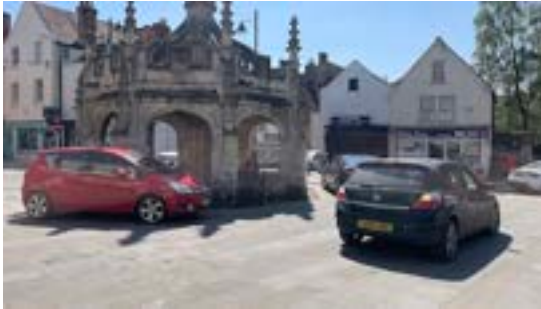
Photo 4.4a

- 4.4 The parking area to the north creates high risks with reversing vehicles. Although there are double yellow lines around the Market Cross, there is a near constant stream of vehicles parked here, some legitimately with blue badges but mostly just for short stop-offs to use the shops. This mars the setting of the Market Cross. The constant vehicle movements mean a high risk of vehicle strikes; most probably causing more damage to the vehicles than the masonry, but a waste lorry caused substantial damage recently. The stone paving in the square is deteriorating in places (see photo 4.4d). Re-landscaping of the area around the Market Cross would be a substantial benefit – wider pavements and a higher kerb with cast iron bollards would substantially protect the building and improve the setting (4). Developing a landscaping project here would probably be the best value project to protect the Market Cross fabric (1).

4.03	Deliver a re-landscaping project to the north of the monument to protect it from vehicle strikes and improve the setting; wider pavements; higher kerbs against the Market Cross; bollards; replacement stone paving and traffic exclusion measures.	N	4.4	50,000
