MALMESBURY MARKET CROSS

2023 Condition Survey

dittrich**hudson**vasettiarchitects

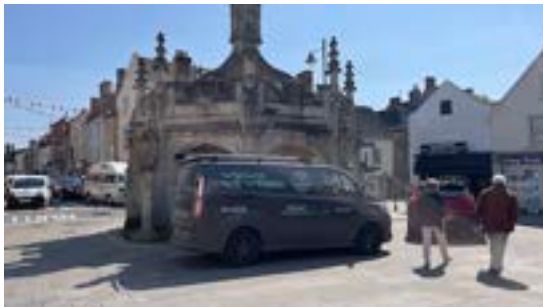
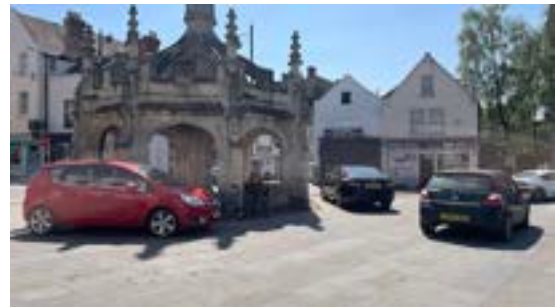
Photos 1.4.5a & 1.4.5b: The monument crowded by vehicles

- 1.4.4 The loft hatch is rotten and needs to be replaced with a new lead cover.
- 1.4.5 The landscaping around the monument needs improvement. Drains are blocked and the southern paved area does not drain well. The north of the Market Cross is very vulnerable to vehicle strikes and has no protection from the constant stream of vehicles that park and turn in close proximity to the stonework. Parking against the monument significantly mars the setting and safety of users. The stone paving in the square is deteriorating due to heavy vehicle movements.

1.4.6 The monument needs protection with wider pavements; a high kerb; bollards; traffic control. This would require a landscape project that will have to extend into the square. This is probably the most important recommendation of the condition survey.

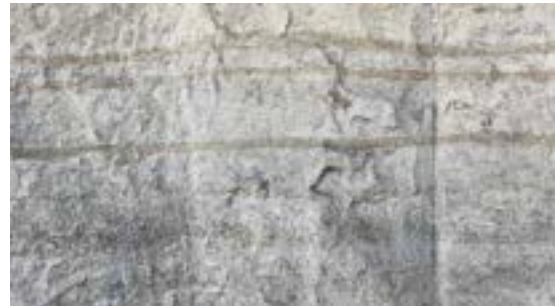
Photo 1.2b

1.2 Bay 1 (N) has a very weathered spandrel to the east (photos 1.2a and 1.2b), and a crisper, leaf-carved spandrel to the west. There is some scaling to the east spandrel and arch stone. The low-level ashlar is very worn and joints are washed out and would benefit from pointing (2). The buttress crocket finials are intact (they are 'engaged' stone so will be secure) – see photo 1.2c. There is some weathering of stone below the parapet, and to the base stone (photo 1.2d), but this doesn't warrant conservation work for now. Moss should be removed from the string course (1). The buttress finial to the south is secure.

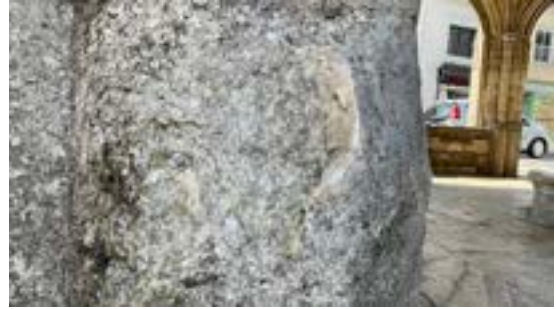
Photo 1.3b

- 1.3 Bay 2 (NE) has quite weathered spandrels (photo 1.3a) and the arch stonework is quite scaled (photo 1.3b). There is a small area of mechanical damage to the south and some blistering to the north (photos 1.3c and 1.3d), however, no conservation work is warranted for now. A finial crocket head to the south is loose. It is secured by a rod but needs to be re-pinned and pointed (1) – see photo 1.3e. The parapet stonework is weathered, but apart from moss removal (1), no conservation work is warranted.

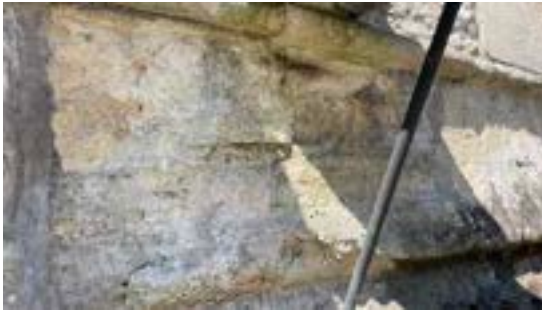
Photo 1.4c

- 1.4 Bay 3 (E) has very weathered spandrels and arch stonework. There's been some stone replacement to the north arch. An area of stone beneath the gutter spout is very friable (see photo 1.4c) and needs extensive full-face mortar repairs, or replacement with stone-tile repairs or stone replacement (2). Moss needs to be removed (1). There is a crack to the mortar behind a previous, poorly-pieced-in stone repair to the north buttress arris (photo 1.4d). Ideally a replacement stone-piecing-in should be fitted, coursed to match the joints (2).

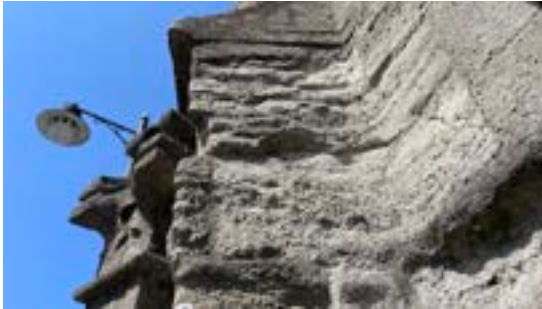
Photo 1.6c

- 1.6 Bay 5 (S) spandrel carvings are completely missing now due to stone weathering. The arch visibly sags but this is most likely to be historic movement. There has been quite a bit of stone replacement to the west parapet. Older stones are very weathered, particularly to the west buttress head (photo 1.6c). There is a crack to the west buttress arris (photo 1.6d) which needs a stone piecing-in repair **(2)**. One of the crocket heads to the west is loose and needs to be pinned and pointed in **(1)** – see photo 1.6e. Low-level stonework is weathered (photo 1.6f) but pointing is still intact.

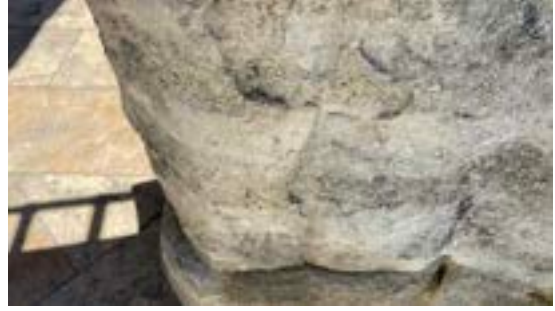
Photo 1.7b

- 1.7 Bay 6 (SW) has two intact carved spandrels (the entire arch head is replacement stone). There is some scaling to the east arch joint (photo 1.7b). The band of stone above the projecting cornice is quite friable and previous mortar repairs have fallen off. For now, it would probably be best to leave it to weather before intervention is warranted.

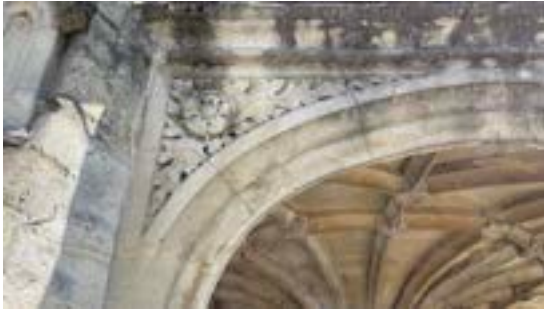
Photo 1.8a

1.8 Bay 7 (W) spandrel and arch stonework is all replacement stone and is weathering well. A lower jamb stone has a crack (photo 1.8b) which could be raked-back and pointed (2) and there is some scaling to the south buttress (photo 1.8c). The finial head to the south (photo 1.8d) has a crack at the neck and wobbles – it should be pinned and pointed in (1).

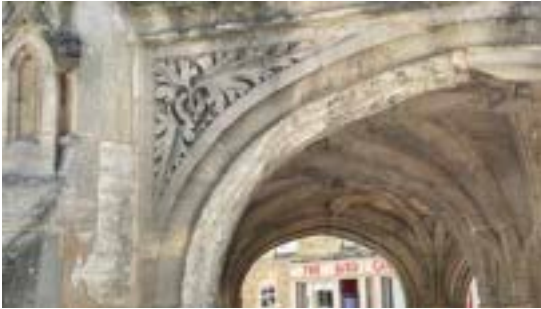
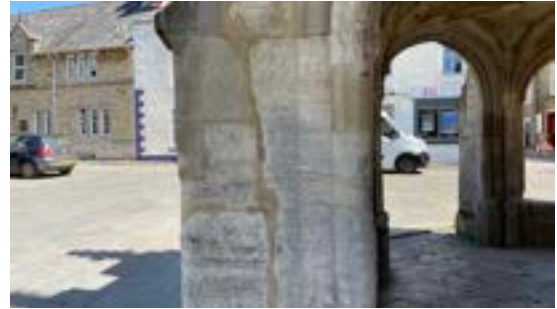
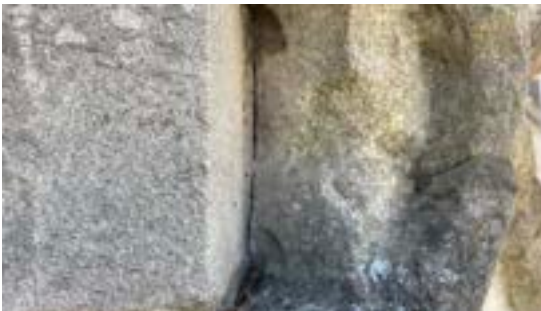
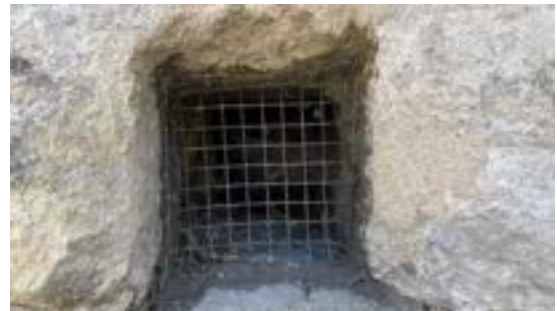
- 1.9 Bay 8 (NW) has crisply-carved spandrel replacements. The lower-level jambs have some scaling and there is erosion to the seat stone at the base, but generally, this bay is in good order. The buttress to the east (to Bay 1) has had recent deep pointing repairs by the contractor AC Nurden Ltd. following a waste lorry strike (photo 1.9b). Mortar is all intact. The west buttress finial has an open perp joint behind – it is a replacement stone so might just have been poorly bedded. The vent opening for the roof space has been infilled with mesh fixed with resin – it is secure for now but this isn't the best fixing method -see photo 1.9d. These openings should be regularly inspected as pigeons must not be allowed back into the roof space (1). The rusting litter bin here should be replaced or relocated as it mars the setting of the Grade I listed building (2).

2.02	Replace the adjacent rusting litter bin to the north.	Y	1.9	500
2.03	Replace the rotten roof hatch.	N	3.9	1,250
2.04	Commission a programme of rope access conservation repairs to the vulnerable lantern statuary.	N	3.15	5,000
Total of all work which should be undertaken within the next 4-5 years excluding VAT, fees, contingency and inflation (£)				9,250

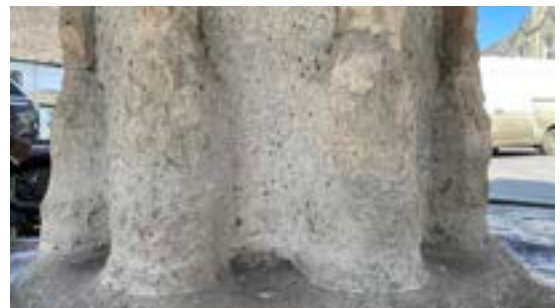
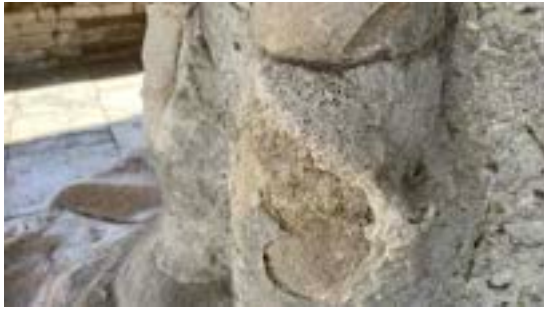
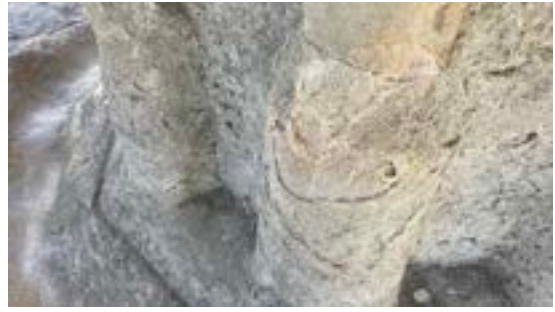
- 2.2 The central shaft has a very worn bench seat. The shaft base above is very scaled with spalling stone. All carving detail has gone. Some conservation work would be ideal, but it might be vulnerable to damage at sitting level.

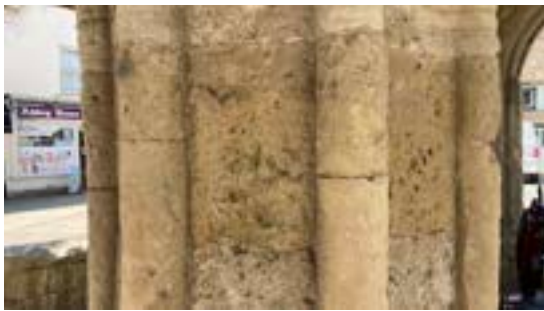
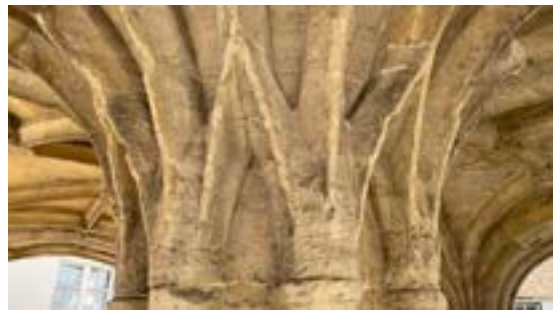
- 2.3 The main pier has had replacement shafts on all sides. These are weathered but still intact. The capitals have interesting hood arches from which spring the 16 ribs. These have had mortar repairs in the past which are now eroded. They are probably fine to leave to weather-back.

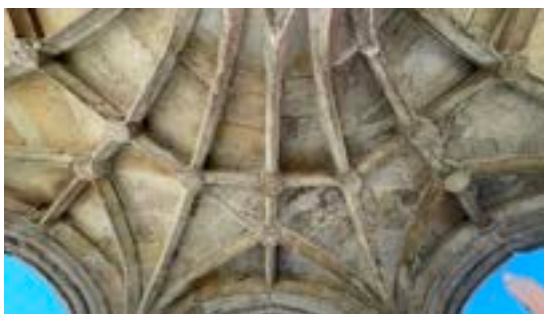
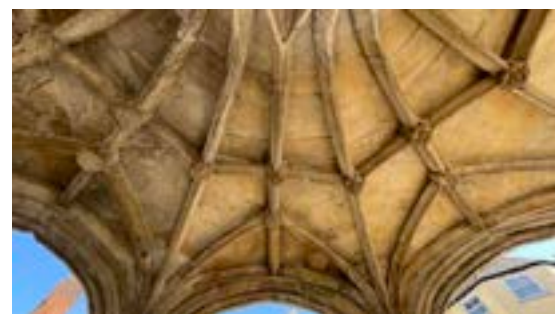
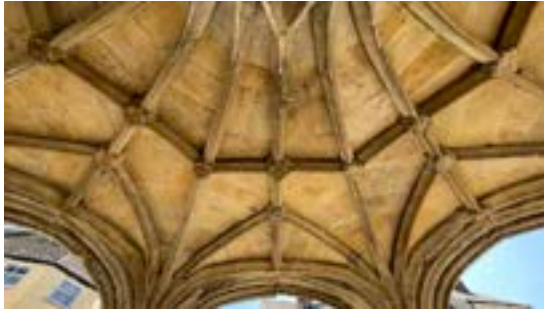
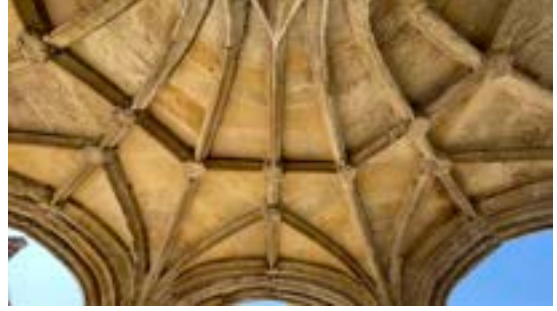
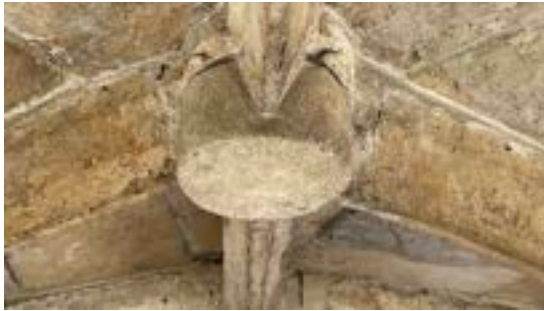
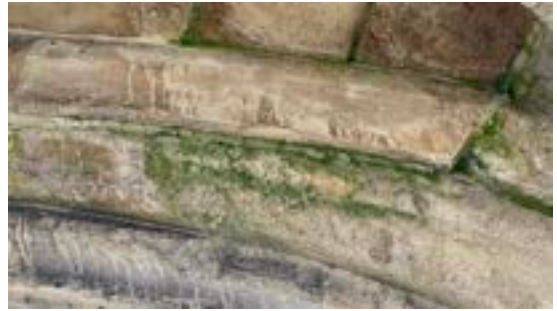
- 2.4 Sections of vaulting have been previously replaced to Bays 3 (east); Bays 4/ 5 (south); Bays 6/ 7 (west – almost entirely replaced); and Bay 8, although some bosses were retained. The vaulting generally is in good condition. Some bosses retain crisp carving; some are weathered and the replacements to Bays 3/ 4 have been left entirely uncarved (a Brakspear motif). No stone repairs are warranted. There is some green algae staining to the east (Bay 3). It's not clear what has caused this as there is no evidence of water ingress to the roofspace above. Some pointing here is loose and would benefit from repointing (3).

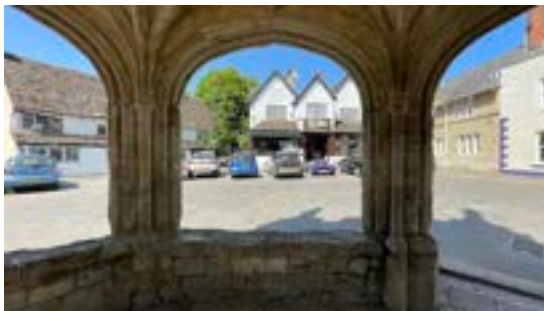
Photo 2.6a

2.6 The outer shaft stonework to Bay 1 (N) is scaled in places. There are mortar repairs to the west jamb. All is fine for now. The low wall is of weathered coursed ashlar with infill stones to the west. Some are fractured and would benefit from mortar repairs (2) – see photo 2.6b.

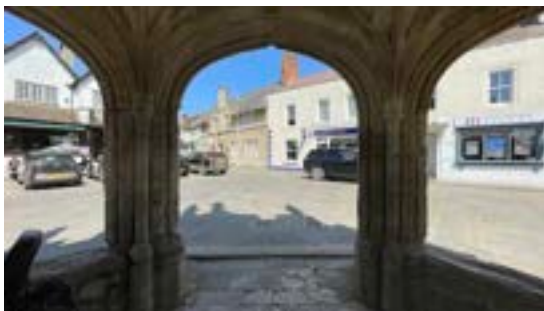
Photo 2.7a

2.7 The open Bay 2 (NE) stone surrounds are weathered to the north. There is a fractured stone to the south at low level which needs a mortar repair to protect it from being knocked off and losing the face (2) – see photo 2.7b.

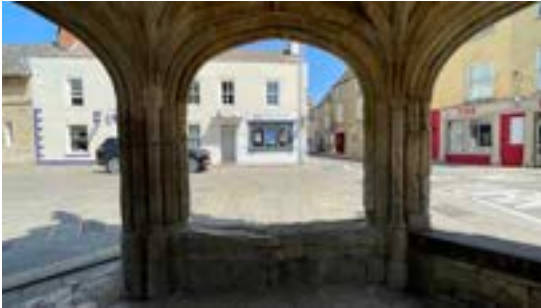
Photo 2.8a

2.8 The outer stonework to Bay 3 (E) is generally in good condition. There is a piecing-in repair to the north which is cracked and eroded on both sides of the perp joint (photo 2.8b), but is fine to leave for now. The limestone wall copings are very worn but intact.

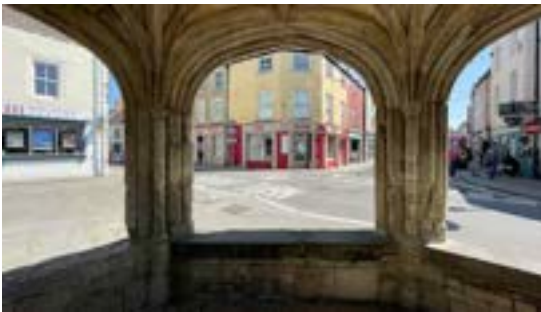
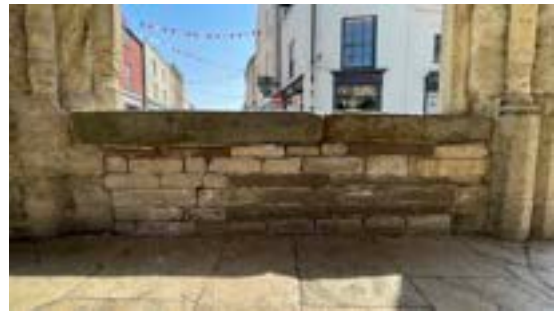
2.9 Outer stonework to Bay 4 (SE) is scaling in places but is generally sound. The wall copings are sandstone which might be accelerating run-off decay below. An area to the south is undercut but is fine to leave for now.

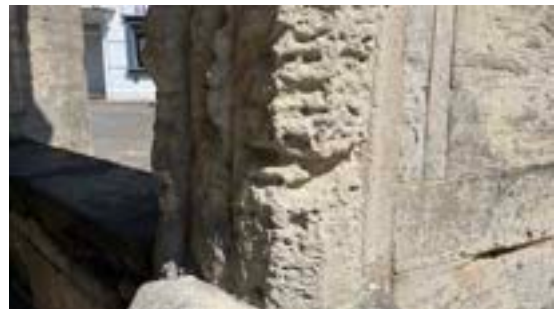
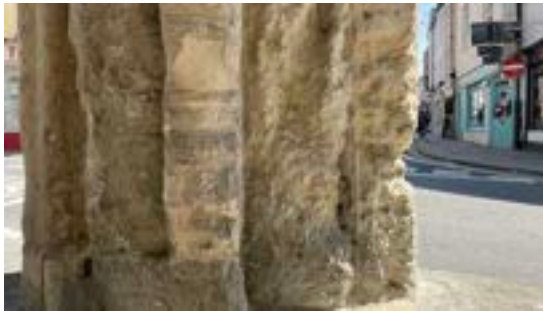
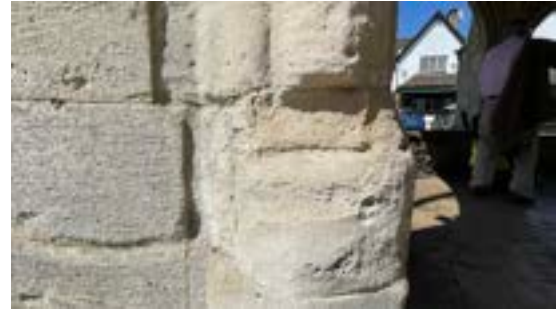
2.10 The east jamb of Bay 5 (S) is very eroded at the base. Stone replacement will be needed in time (3) for now de-frassing and shelter coating may prolong the life of the stone (2). The wall is of squat, coursed squared-rubble with sandstone copings and is markedly different from the outer low wall stonework. Joints are open but the rounded rubblestones won't take re-pointing well.

3.02	Replace the very eroded stone to the east outer jamb of Bay 5 (S).	N	2.10	750
3.03	Replace the lead patches to the gutter flashings, or renew the flashings in shorter lengths.	N	3.5	2,500
Total of all long-term works excluding VAT, fees, contingency and inflation (£)				5,250

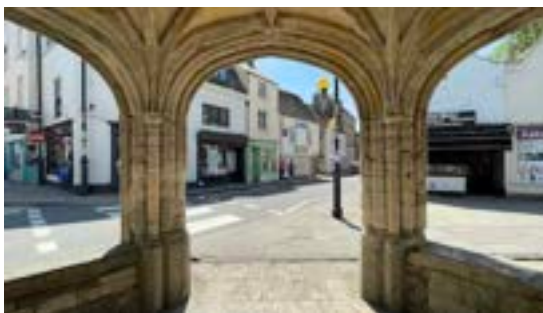
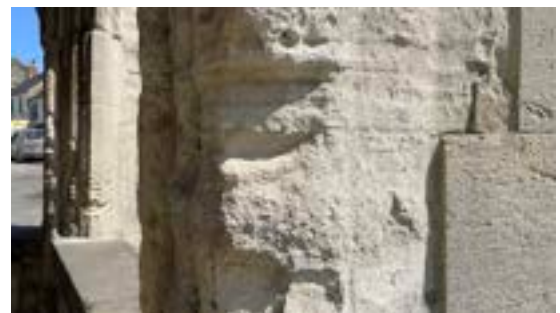
- 2.11 The outer stonework to Bay 6 (SW) is scaled. The south jamb is friable and would benefit from de-frassing and shelter coating to prolong its life (2).

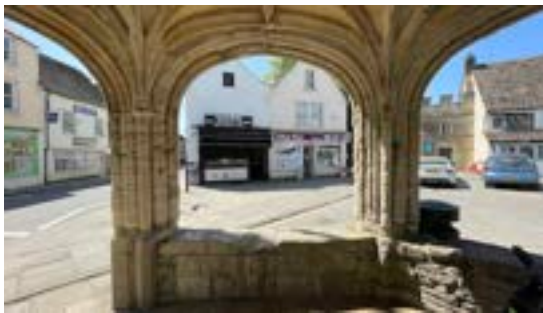
Photo 2.12a

- 2.12 The outer stonework to Bay 7 (W) is free of any major issues. A jamb stone to the north is cracked but repair isn't warranted for now – see photo 2.12b.

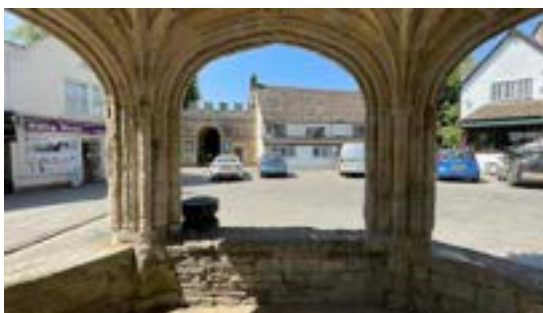
Photo 2.13a

- 2.13 The outer stonework to Bay 8 (NW) is scaled but is generally fine. The low wall is a mixture of coursed and jumper stone in limestone and sandstone. The coping is weathered sandstone – the western end is oddly jointed (see photo 2.13b).

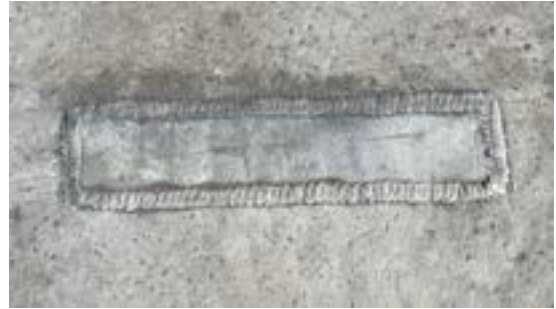
Photo 3.2b

3.2 Lead bays are a maximum of 2.5m long by 0.8m girth, which is adequate for code 7 lead or thicker. Boards are showing through in places, and there are four lead patches. The lead welds to three of these have hairline cracks and should be replaced with larger patches (1) – see photo 3.2b. The upper gutter bays (ie. bays without catch pits) are formed from single pieces of lead welded to a small apron at the catch pit. They are therefore restrained at the point the lead passes through the buttresses. This lead weld will be prone to splitting (a tiny split is forming to Bay 1 (N) – see photo 3.2d). These points should regularly be inspected and lead patch repaired when required (1).

1.03	Regularly inspect the vent meshes to ensure pigeons don't access the roofspace.	Y	1.9	-
1.04	Commission a programme of minor lead repairs – replace lead patches to three lead patches on the roof. Regularly inspect the restrained upper lead gutter bays and patch weld any forming cracks. Replace the gutter upstand lead patch to Bay 7 (W). Repair the crumpled end to the drainage chute to Bay 5 (S), including access.	N	3.2; 3.5; 3.6	1,500

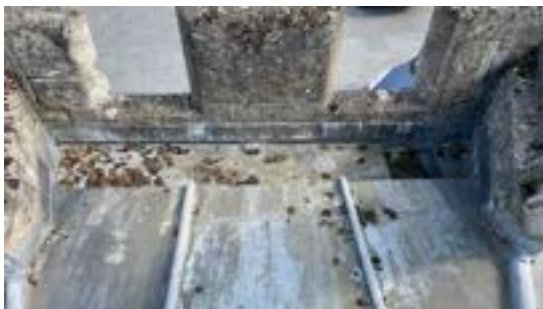
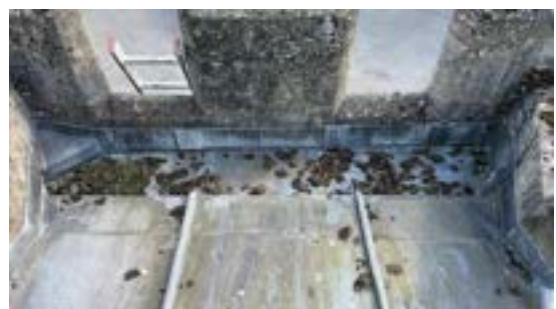
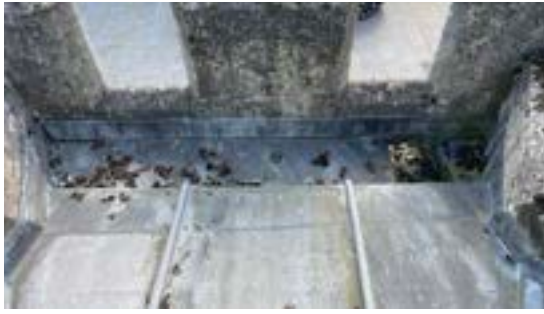
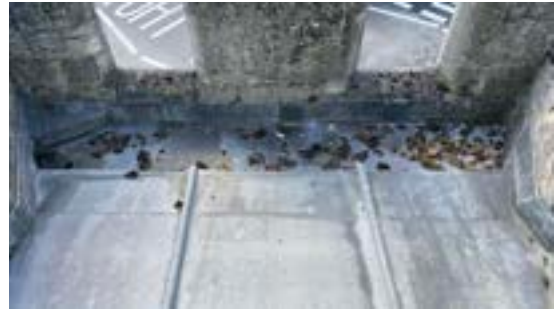
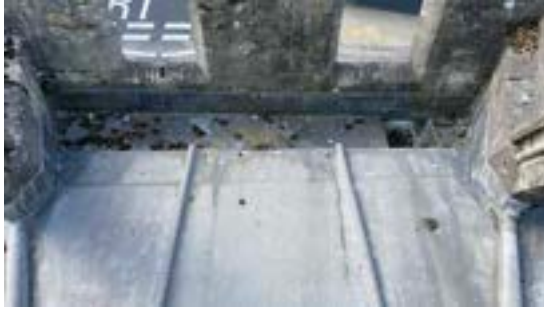
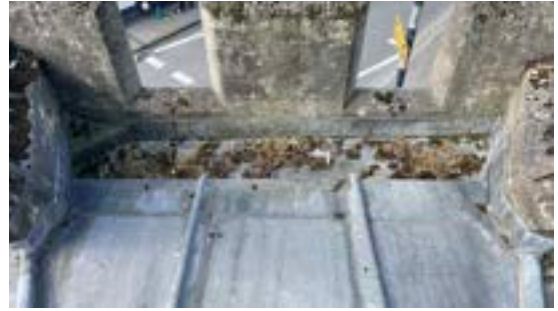
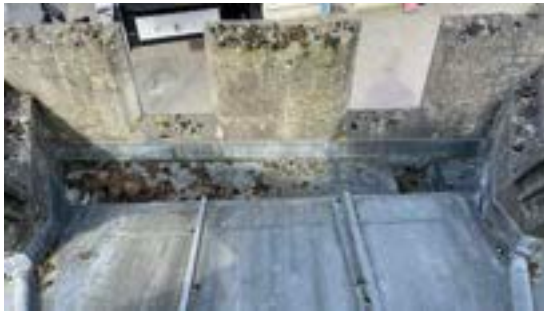
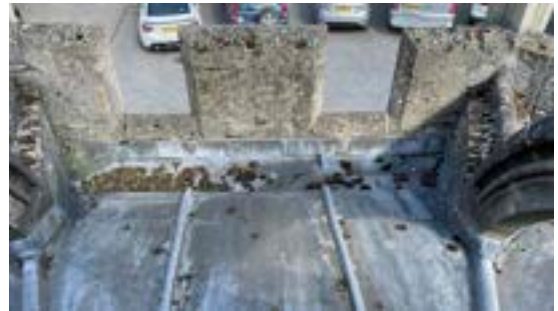
3.4 There is a minimum 120mm fall into the 350mm wide parapet gutters. Flashings are all secure and the lead is well-detailed.

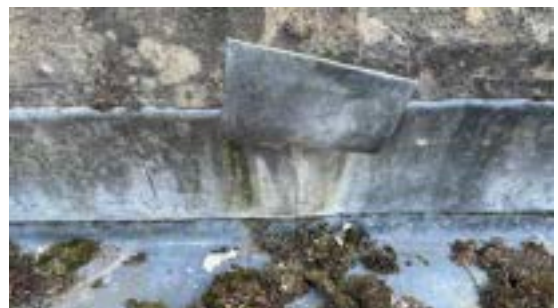
Photo 3.5b

3.5 Parapet flashings have small flashing patches over splits (the flashing are over-long). The Bay 7 (W) patch has come out and needs to be wedged and re-mortared (1) – see photo 3.5a. It is suspected that these patches are not wedged and all may need attention in forthcoming years as thermal movement loosens them (3). The flashing to Bay 6 (SW) has a crack which needs a patch in the longer term (3) – see photo 3.5c.

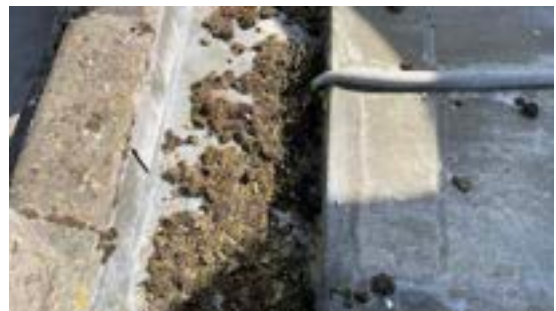
Photo 3.8

- 3.8 There is a high level of moss in gutters (as well as stonework) and this should all be removed by hand with a spatula and water (1) – see photo 3.8.

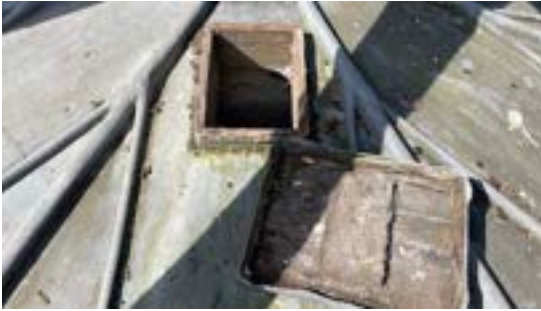
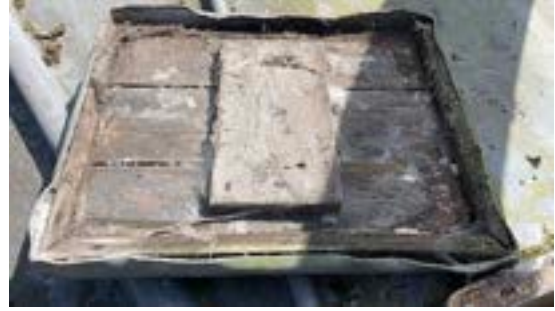
- 3.9 There is a lead lined timber hatch to Bay 2 (NE) which allows access to the vaults beneath. The timber hatch is rotten and needs to be re-formed (2).

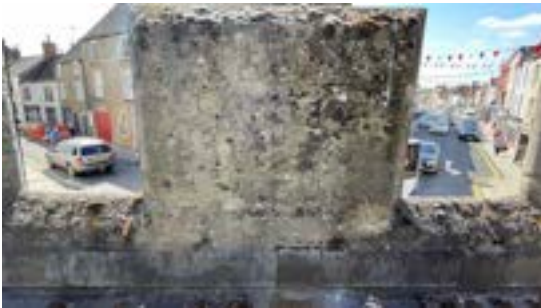
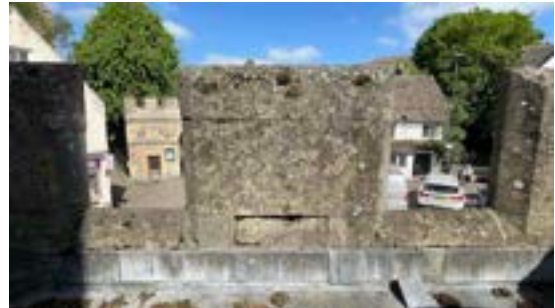
- 3.10 The parapet crenelations are all in good condition. There are small areas of cracked pointing and stone erosion but none that warrant attention for now.

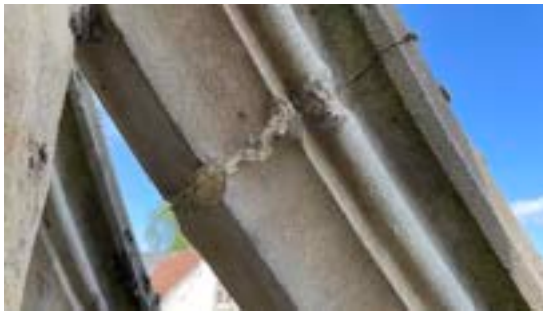
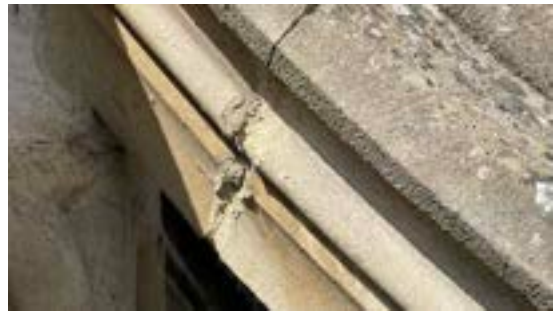
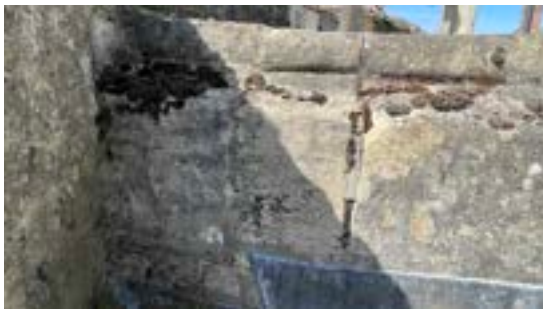
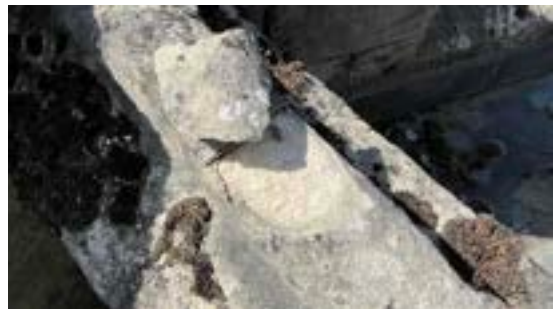
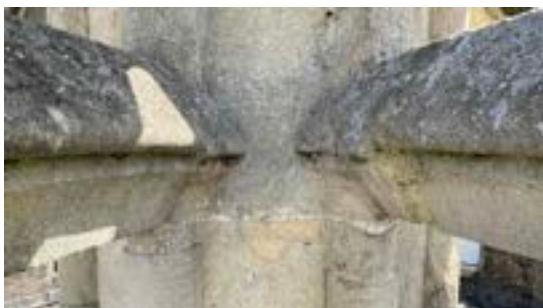
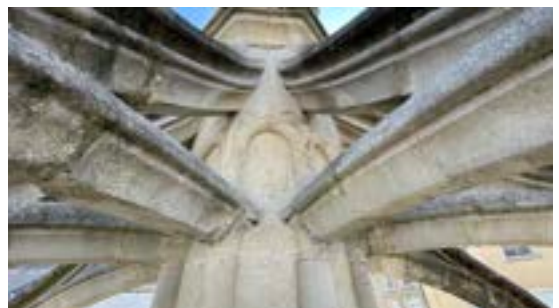
3.13 The eight flying buttresses are in good condition. There are some small areas of stone blistering, loss of pointing and frost damage to a roll-mould, but nothing that would warrant repair for now.

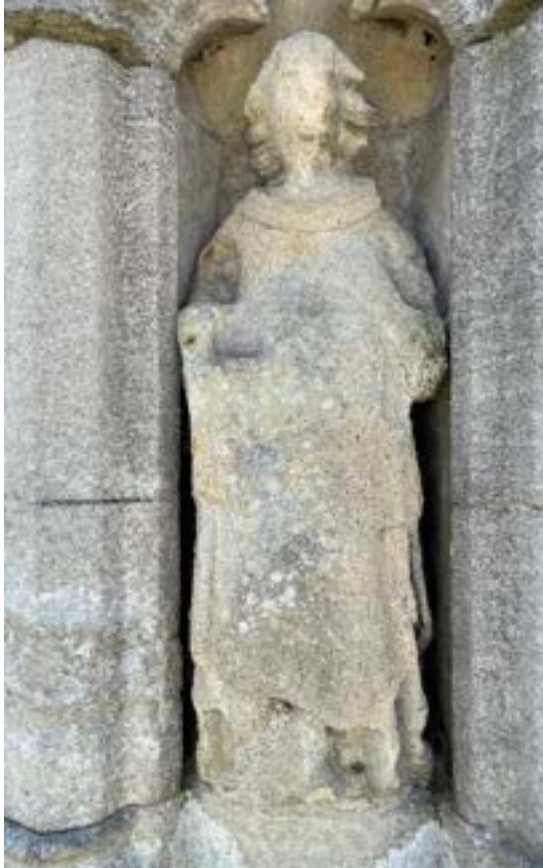
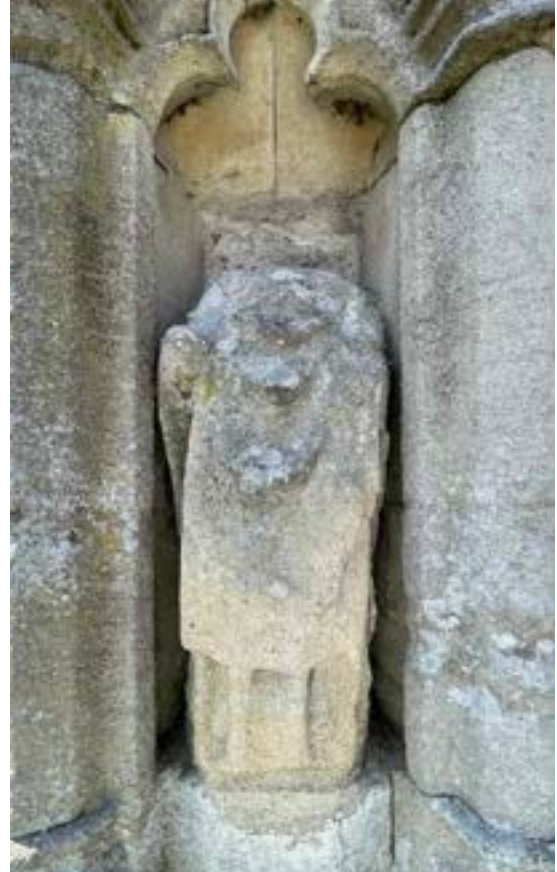
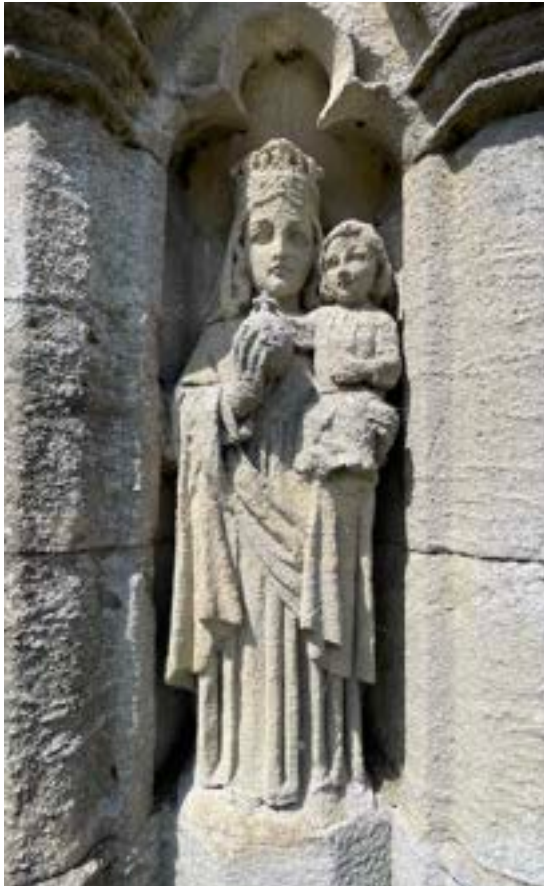
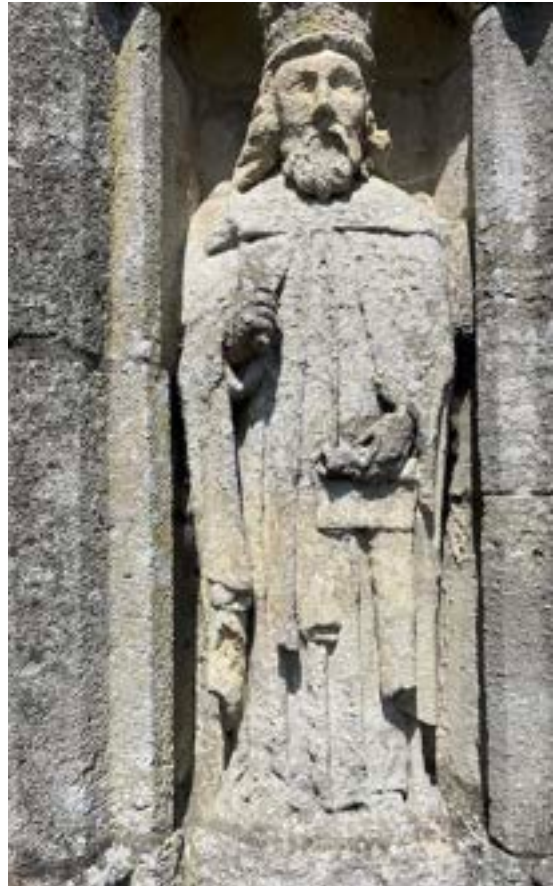
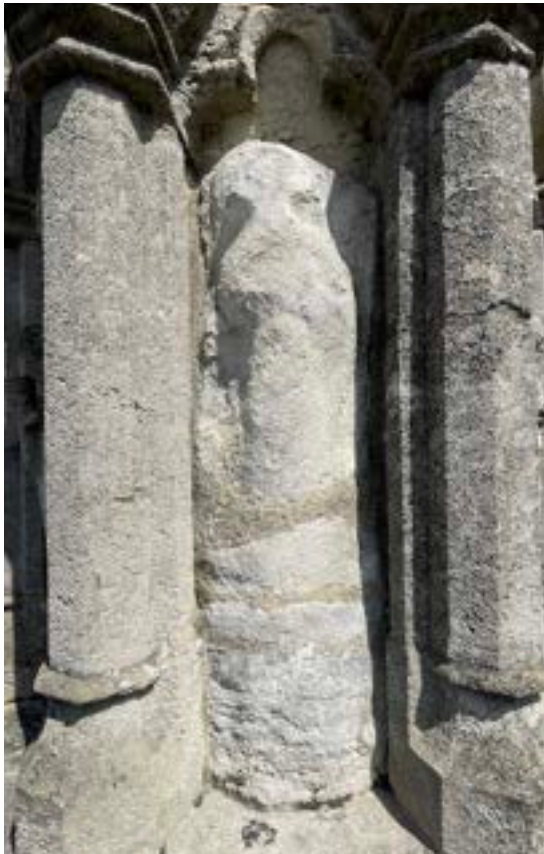
- 3.14 The lantern statuary almost certainly dates from the twentieth century (they were all reported to be traces only in 1909). They are difficult to access for inspection, but some are clearly not aging well. The stone is eroded and some statues are barely discernible. The statue of St Aldhelm to Bay 2 (NE) is missing a head and the statue in Bay 5 (S) is completely eroded (and might be pre-1909). Pigeons perch on the statuary heads and guano will accelerate stone erosion, but little can be done about this.

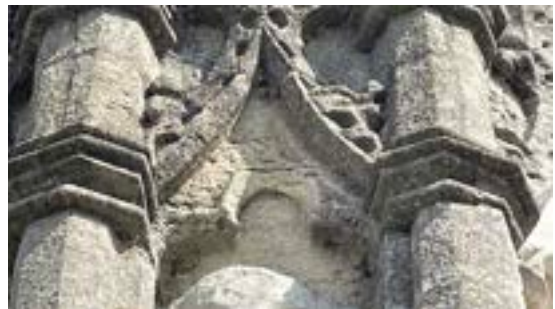
Photo 3.15b

- 3.15 The fine carving is vulnerable to weathering. There are a lot of previous mortar repairs, some of high quality, and some are now detaching. There is blistering to the left ear of King Athelstan , and to the cusped mould over Bay 5 (S). Protective lead weather hoods may arrest deterioration, and some conservation treatment would be ideal to prolong the life of the statuary (2) – this may be more cost-effective by rope access.

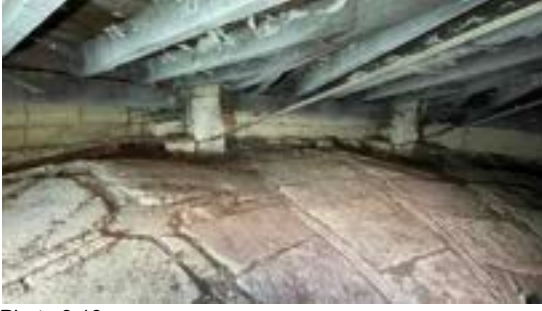
Photo 3.16a

- 3.16 The roof space is dry (albeit after a long period without rain). Radial rafters span to large beams which span between the buttress stones. All timberwork is tarred softwood and appears to date from the Brakspear restoration phase. The vault stonework is intact. Bronze tie rods span from the lantern base to the buttresses. They aren't particularly tight and their contribution to the integrity of the structure might be questionable.

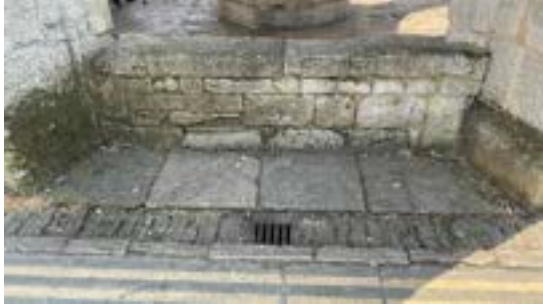
Photo 4.1a

- 4.1 The waterspouts drain to a stone set margin which drains to gullies to the north (photo 4.1 a), east (photo 4.1b) and west (photo 4.1c). The south spout water thus has a long route to drain to the side gullies across a threshold (photo 4.1d) – water probably just sinks into the ground. The east and west gullies need cleaning out as a matter of urgency (**U**).

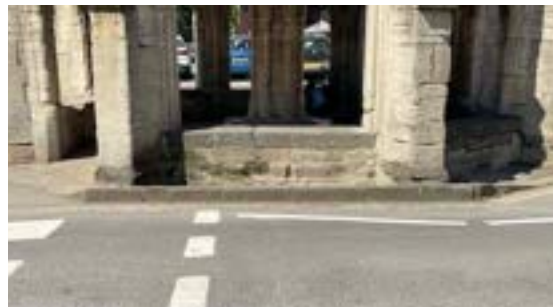
Photo 4.3b

- 4.2 Re-paving the margin stonework with dished channels and better falls from the south in particular would be desirable (**4**).
- 4.3 A high sandstone kerb to the south road provides limited protection from vehicles. Lorries in particular struggle to make the turn from High Street to Gloucester Street and there is a high risk of vehicle strike here, but there might not be much scope for improvement to the junction. CCTV coverage would be very useful to cover this junction so that vehicle strike damage can be pursued via vehicle insurance – HGVs are frequently routed through the town when drivers use inappropriate sat navs (**4**).

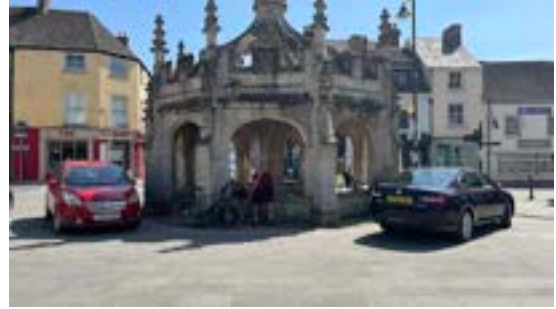
Photo 4.4b

- 4.4 The parking area to the north creates high risks with reversing vehicles. Although there are double yellow lines around the Market Cross, there is a near constant stream of vehicles parked here, some legitimately with blue badges but mostly just for short stop-offs to use the shops. This mars the setting of the Market Cross. The constant vehicle movements mean a high risk of vehicle strikes; most probably causing more damage to the vehicles than the masonry, but a waste lorry caused substantial damage recently. The stone paving in the square is deteriorating in places (see photo 4.4d). Re-landscaping of the area around the Market Cross would be a substantial benefit – wider pavements and a higher kerb with cast iron bollards would substantially protect the building and improve the setting (4). Developing a landscaping project here would probably be the best value project to protect the Market Cross fabric (1).
